Minerals Inspection Report

Mine Name: Barneys Canyon Mine	Permit Number: M/035/0009	Mine Status: Active
Operator Name: Rio Tinto - Kennecott Utah Copper	Inspection Date: August 21, 2013	Permit Fees: Paid
Inspector(s): L Heppler, A Abate, T Nicolaysen	Inspection Time: 11:00 AM	Bond Amount: \$3,873,446
Attendee(s): T Lindsay, T Heaton	Weather: Sunny, Dry	Bond Escalation: 06/22/2014
Inspection Purpose: Routine annual inspection		Prior Inspection: May 10, 2012

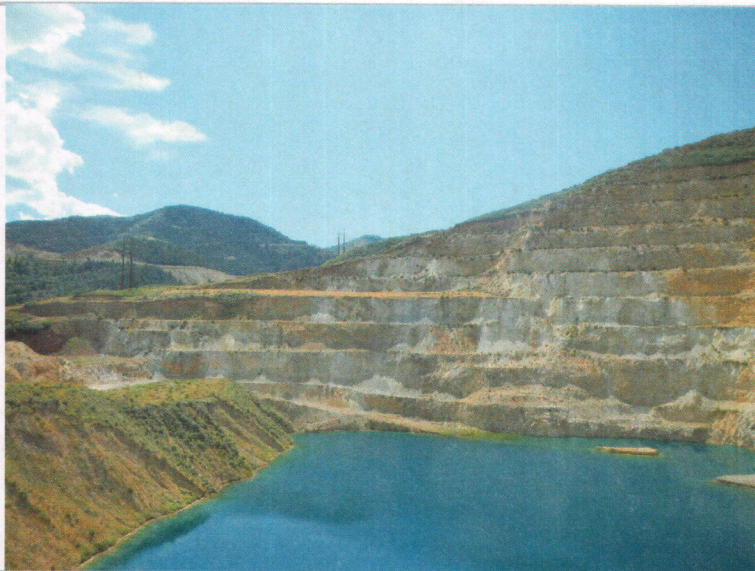
Reclaimed Pit

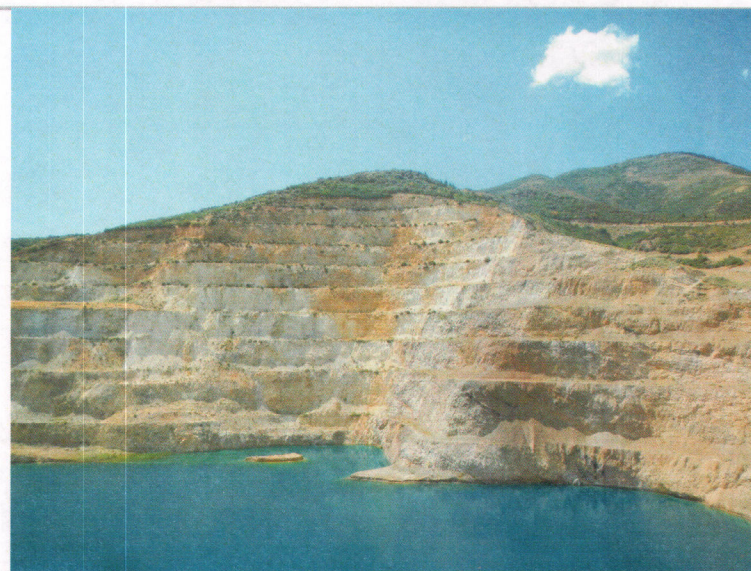
Reclaimed Pit

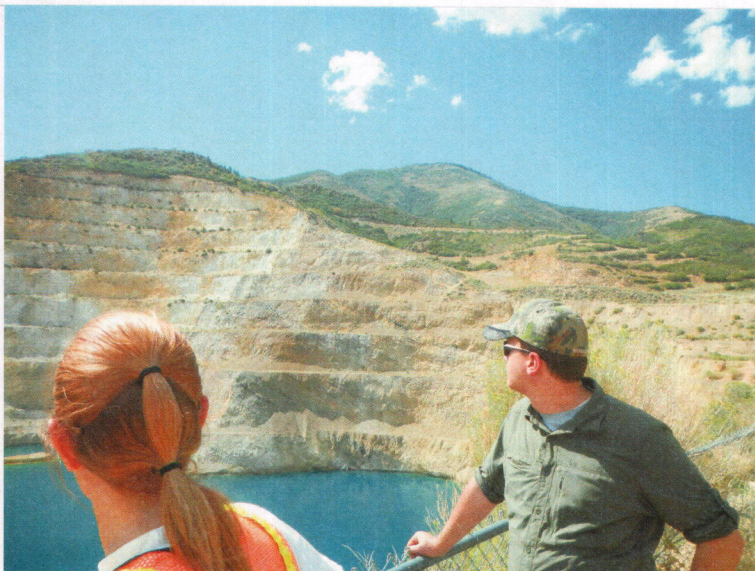
Reclaimed Pit

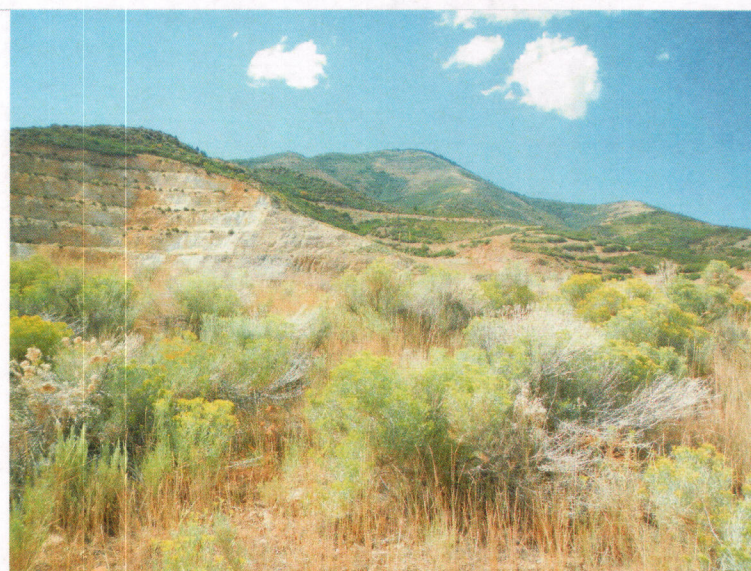
8. <i>Soils</i> No soil stockpiles are noted at the time of inspection.	<input checked="" type="checkbox"/>	<input type="checkbox"/>
9. <i>Revegetation</i> Revegetation is doing well - see attached photos	<input checked="" type="checkbox"/>	<input type="checkbox"/>

Revegetation has been reestablished
